Whitehall Pool and Tennis Club (WPTC)

**UPPER PATUXENT RIVER WATERSHED RESTORATION ACTION STRATEGY (WRAS)
FORM 1 -- Catchment Information**

**UPPER PATUXENT RIVER WATERSHED RESTORATION ACTION STRATEGY (WRAS)
FORM 2 -- Site Information**

Site Name: Whitehall Pool and Tennis Club Address: 12414 Whitehall Drive, Bowie MD, 20715

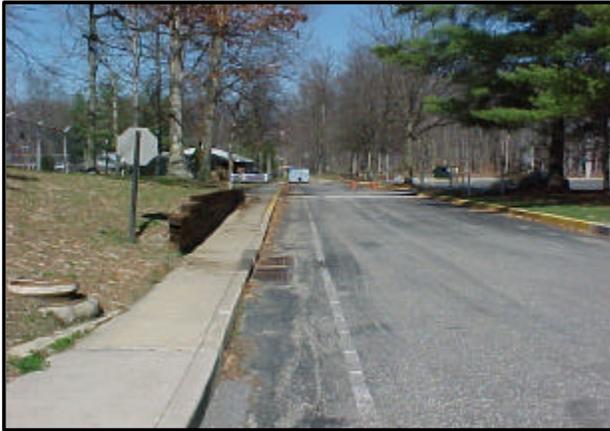
- No. 508 Description: looking northeast from entrance
- No. 509 Description: looking northwest along west side of parking lot
- No. 510 Description: looking northeast along south side of parking lot
- No. 511 Description: looking northwest along east side of parking lot
- No. 512 Description: looking southwest to entrance
- No. 513 Description: looking north across tennis courts
- No. 514 Description: looking northeast across pool
- No. _____ Description: _____
- No. _____ Description: _____
- No. _____ Description: _____
